Manhole Inspection Summary

Manhole # S29II_019MH

Insp Date: **4/9/07 1:57 PM**

Location Address: **1735 LAURENS ST**

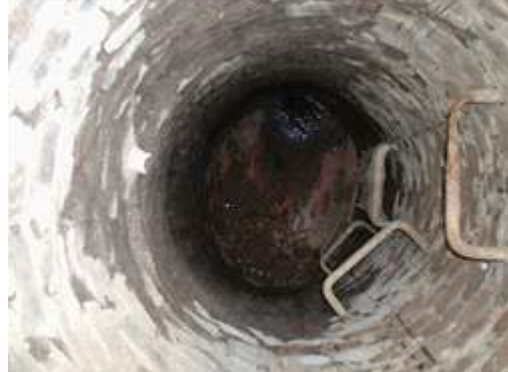
Top View

Channel debris. Corroded steps.

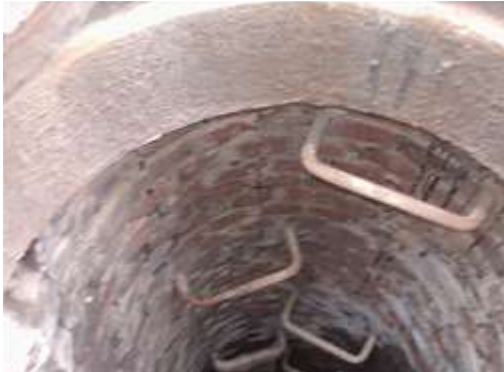
Defect

Frame leaks. Frame offset. Adjustment deterioration, loose brick and infiltration. Corbel and Barrel infiltration - other side.

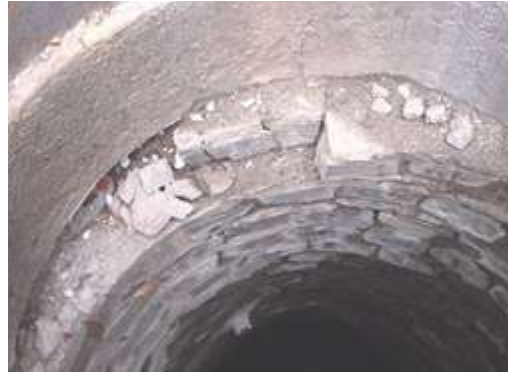
Defect

Frame leaks. Frame offset. Adjustment deterioration, loose brick and infiltration. Corbel and Barrel infiltration.

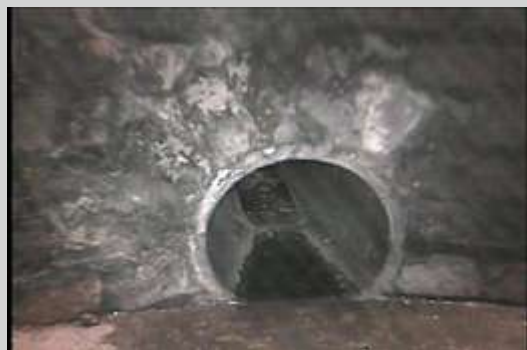
Pipe Out @ 12 O'Clock

Barrel infiltration.
